# Piezoelectric sensing-based local damage detection for steel frame buildings

**Objective:** This research tries to develop quick and effective seismic damage detection techniques that can quantitatively identify local damage in structural elements.

**Methodology:** The polyvinylidene fluoride (PVDF) piezo film is adopted as a dynamic strain sensor for detecting local damage in a 1/3.75-scale steel frame testbed constructed in the laboratory of DPRI. The PVDF film is characterized by high sensitivity, excellent flexibility, wide-range frequency, and direct bonding with structural surface.

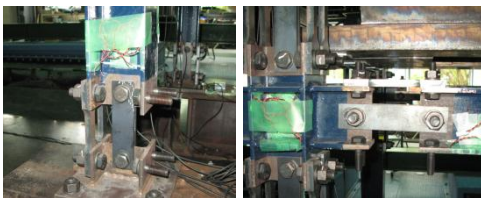
Column damage

Beam damage
